Incident Summary #II-762099-2018 (#9286) (FINAL)

SUPPORTING INFORMATION	Incident Date	October 24, 2018	
	Location	Langley	
	Regulated industry sector	Refrigeration – Boilers and Pressure Vessels	
	Impact	Qty injuries	0
		Injury description	N/A
		Injury rating	N/A
	Damage	Damage description	Ruptured evaporator (also referred to as heat exchanger or cold trap) released estimated 485 to 1,500 lbs of ammonia from refrigeration system and resulted in an extensive area evacuation for two days.
		Damage rating	Major
	Incident rating	Major	
	Incident overview	<p>After unscheduled maintenance to drain oil from the pumps, the refrigeration system was noted to be slow to return to performance and oil contamination of some system evaporators was suspected.</p> <p>The responding refrigeration mechanic stated he attempted to improve system performance by closing valves to generate pressure within an evaporator to move or dislodge potentially trapped oil. The pressure rose very rapidly once the evaporator was isolated between closed valves, breaking a pressure gauge needle (photo 3) and rupturing the evaporator (photos 1 and 2).</p> <p>An estimated 485 to 1,500 lbs of ammonia was released from t

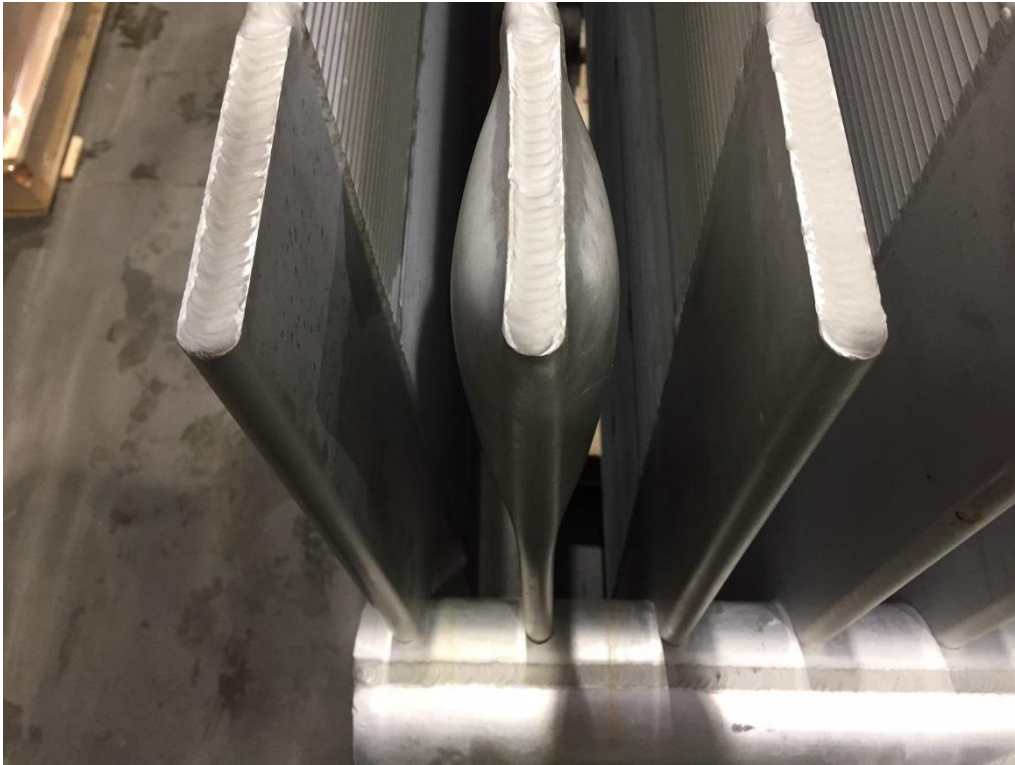
Photo 1: Heat exchanger plate showing bulge deformation on both sides of the plate.

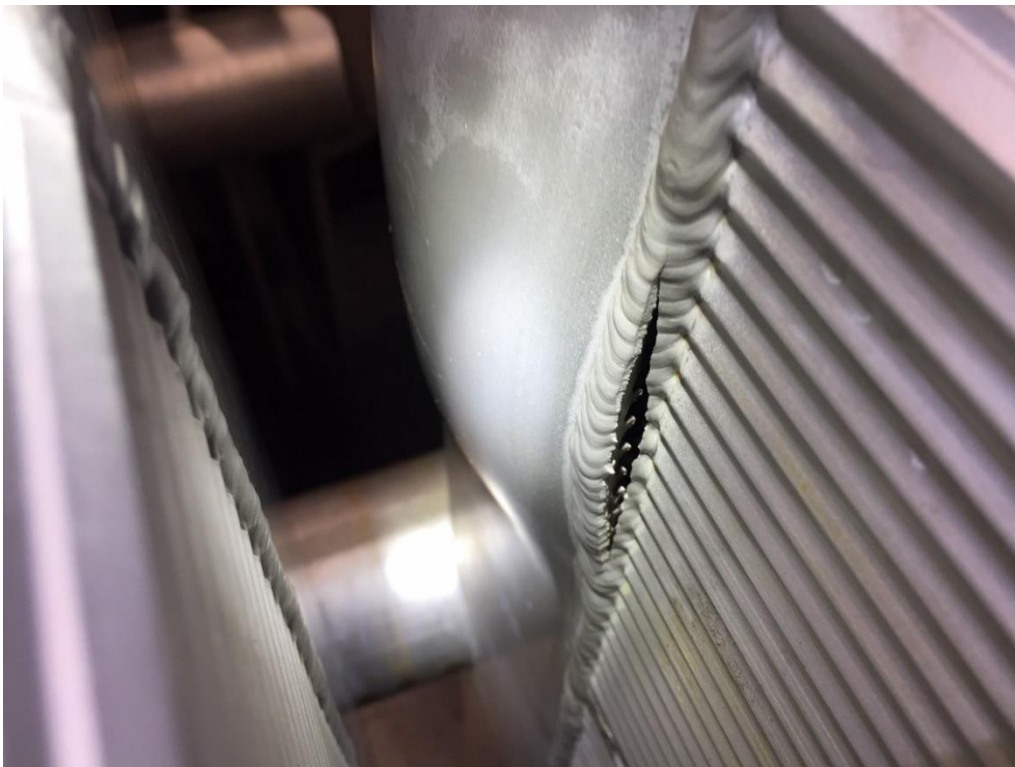
Photo 2: Failed weld on heat exchanger plate at location of bulge deformation. Similar weld failure on opposite side of plate.

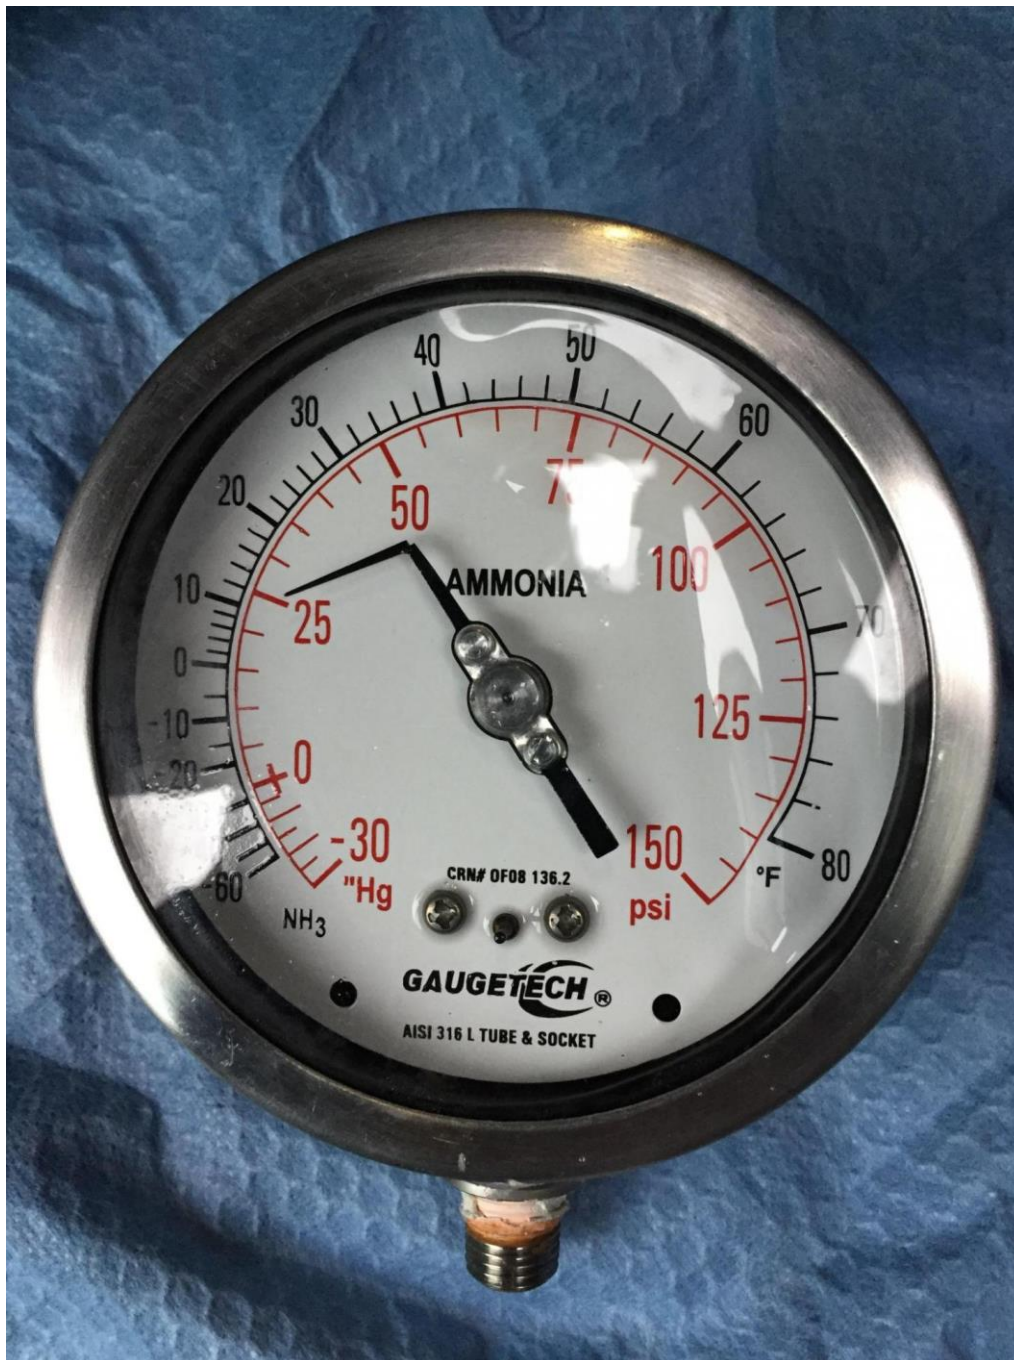
Photo 3: Broken ammonia pressure gauge – needle is broken at location of stopper pin and internal calibration mechanism shows deformation or offset.

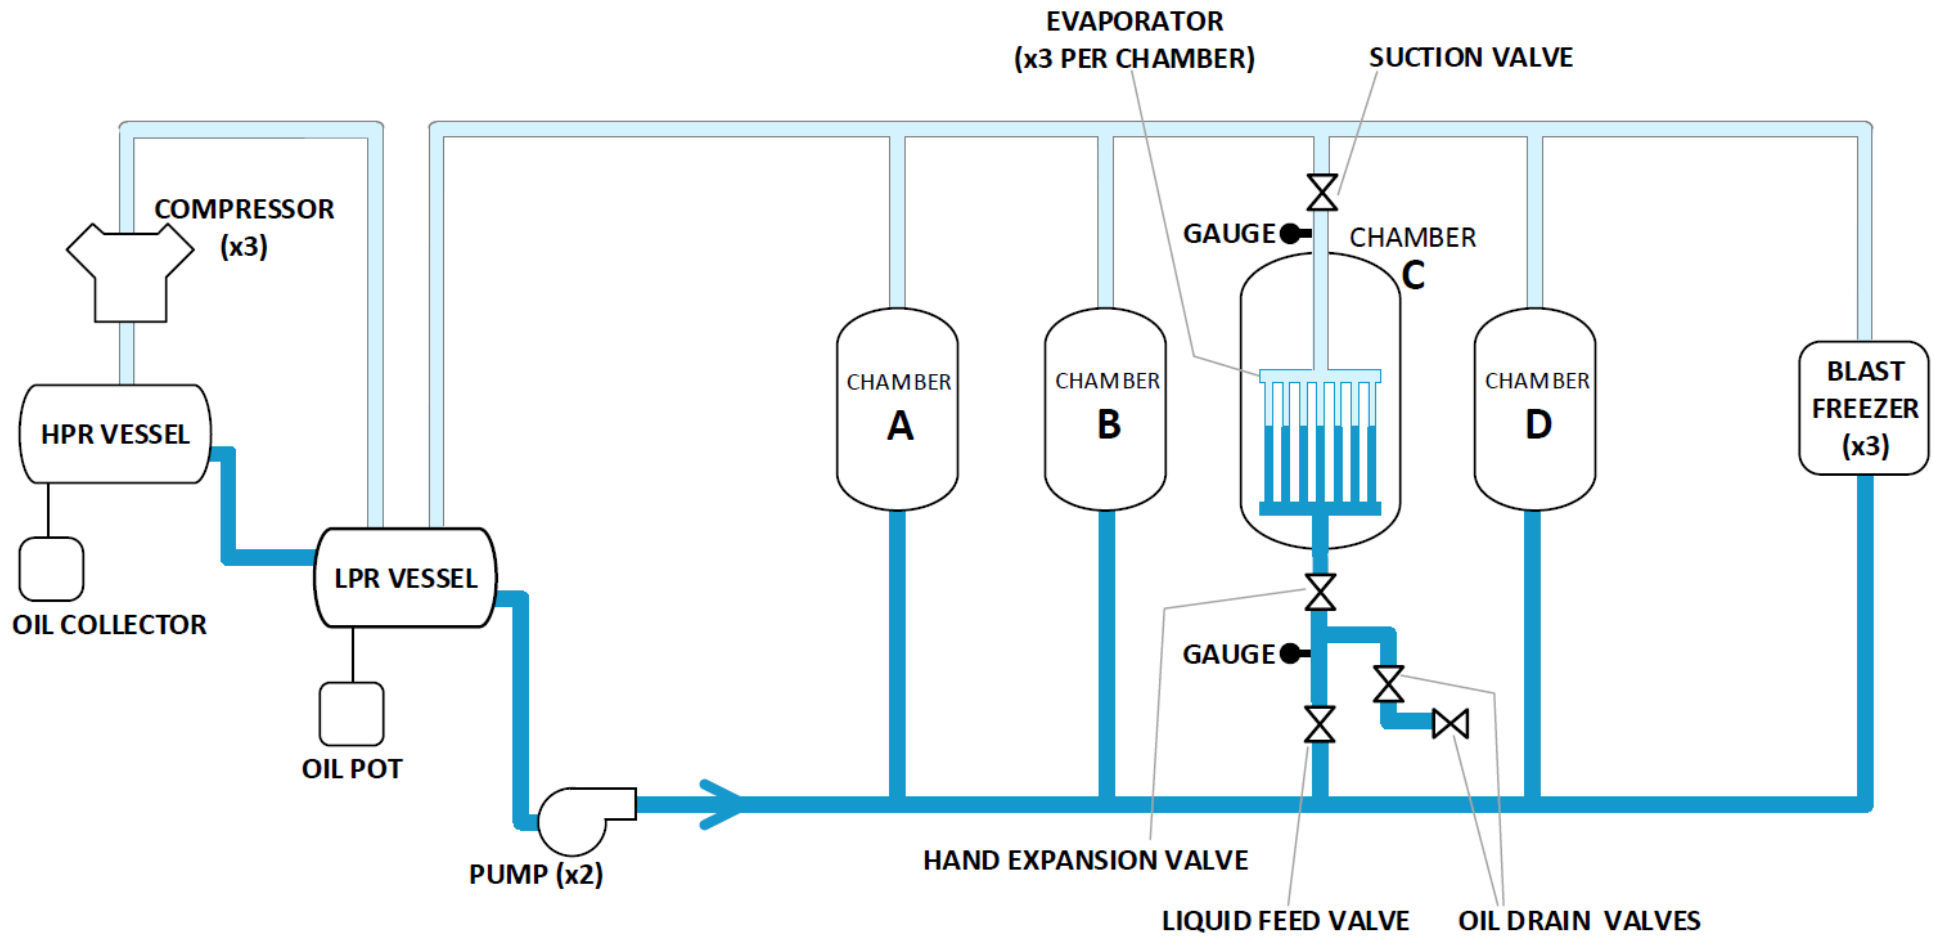
Diagram 2: Simplified refrigeration system schematic

INVESTIGATION CONCLUSIONS	Site, system and components	<p>The refrigeration system is depicted in Diagram 2, consisting of four operating chambers (A, B, C and D) and three flash freezers. Liquid ammonia was pumped to the chambers and freezers to remove heat and moisture. Ammonia was returned to high pressure and low pressure receivers (LPRs) via compressor suction and liquid pump pressure. The total refrigerant charge of the system was identified as 9,500 lbs of ammonia.</p> <p>The LPR incorporated an oil trap to remove compressor oil prior to circulation of the liquid ammonia to the pumps and heat exchangers. Compressor oil is heavier than liquid ammonia and will settle at the bottom of the receiver vessels where oil traps are located or at low points in system piping. Oil from the oil pot would be removed at regular maintenance intervals to prevent accumulation and circulation throughout the refrigeration system. Oil drainage provisions were incorporated at system piping low points located at each chamber.</p>

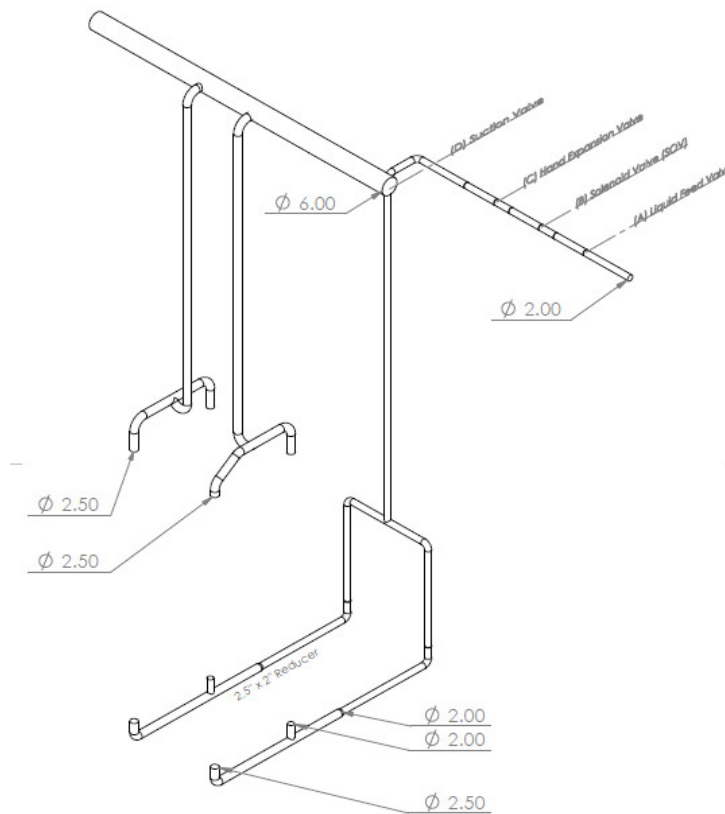
Figure 1: As built wet suction risers prior to being insulated.

The liquid valve train, except for the hand expansion valve, is at an elevation of approximately 14 ft (4.3 m) above the floor. Separate 1-1/4" hand expansion valves and oil drain valves are installed at the floor level for each evaporator section of the large cold trap. There is a single suction isolation valve for both evaporators on the branch suction piping at an elevation of approximately 19 ft (5.8 m) above the floor. Figure 1 shows the as-built piping arrangement.

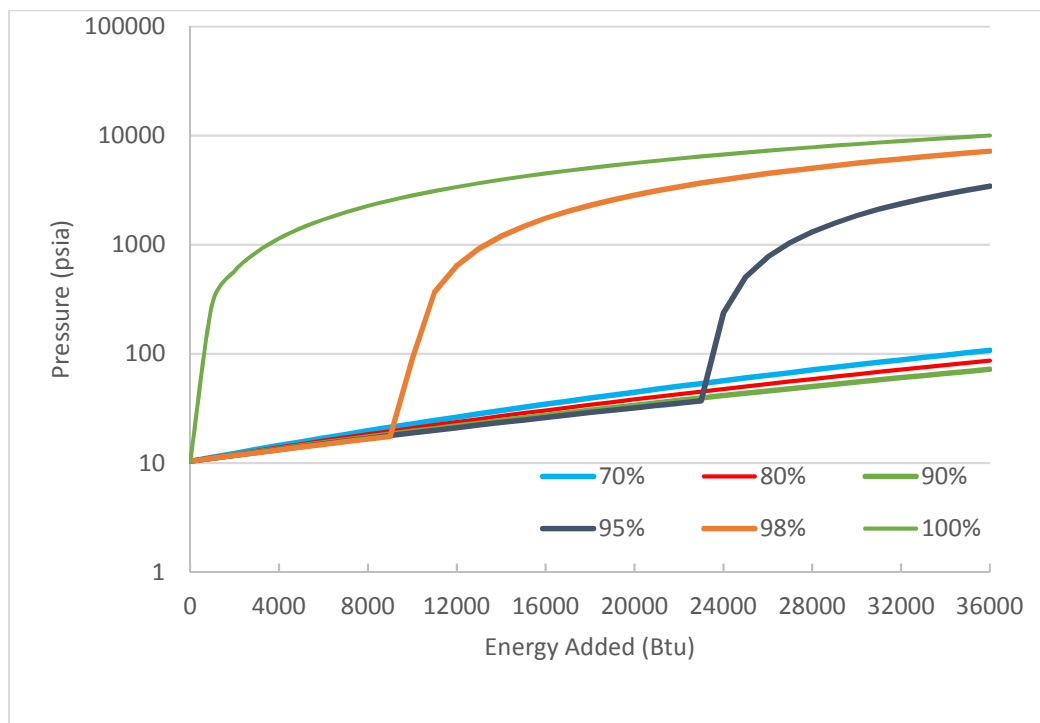
Figure 2: Pressure rise for trapped refrigerant with varying liquid volume quantities (70% to 100% liquid by volume)

Liquid expansion, sometimes called hydraulic lock-up, occurs when energy is added to trapped liquid. Because liquid is not compressible, a rapid pressure increase can occur with a small amount of energy input. Figure 2 shows how this increase would progress with several different liquid/vapour volume ratios based on the typical operating conditions and volume of the isolated components at AFD Canature. The amount of energy used to create the pressure rise shown in Figure 2 is equivalent to the cold trap operating at design conditions for 3.5 minutes.

At AFD Canature, the cold trap was isolated by closing the hand expansion valves first, followed by the suction isolation valve several minutes later. If the evaporator was operating at design conditions, this isolation procedure should not have resulted in a situation where the expansion of liquid would be a concern because there would not have been sufficient liquid present in the evaporator and piping. Additionally, it would be expected that having the evaporator open to the suction piping for several minutes would have allowed some liquid to evaporate, reducing the liquid quantity further.

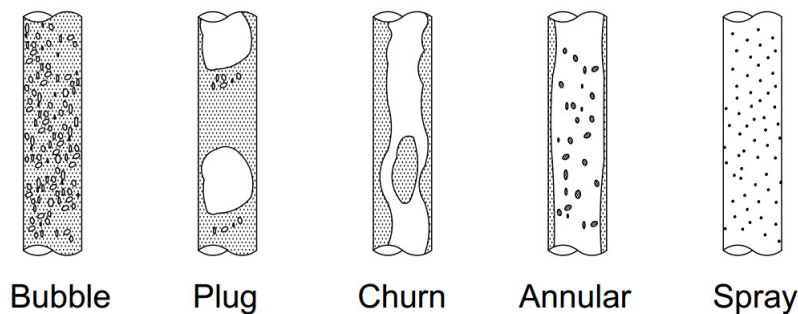
Figure 3: Flow Regimes in vertical suction risers

In a liquid overfeed system, the refrigerant vapour velocity in the suction riser is used to move liquid vertically upwards. Figure 3 shows several different flow regimes that can occur in two-phase vertical flow. A complete discussion of two-phase vertical flow is outside the scope of this analysis; however, it is important to note that as the velocity of the refrigerant vapour increases, there is a point at which flow can be achieved with a minimum pressure drop. It is generally desired to be in an annular flow regime, which is shown on the right side of Figure 3. If liquid is allowed to 'stack', as is shown on the left of the flow regimes in Figure 3, the pressure drop can increase dramatically due to the weight of the liquid refrigerant. Traps in the vertical suction piping add pressure drop and can contribute to the accumulation of unnecessary liquid.

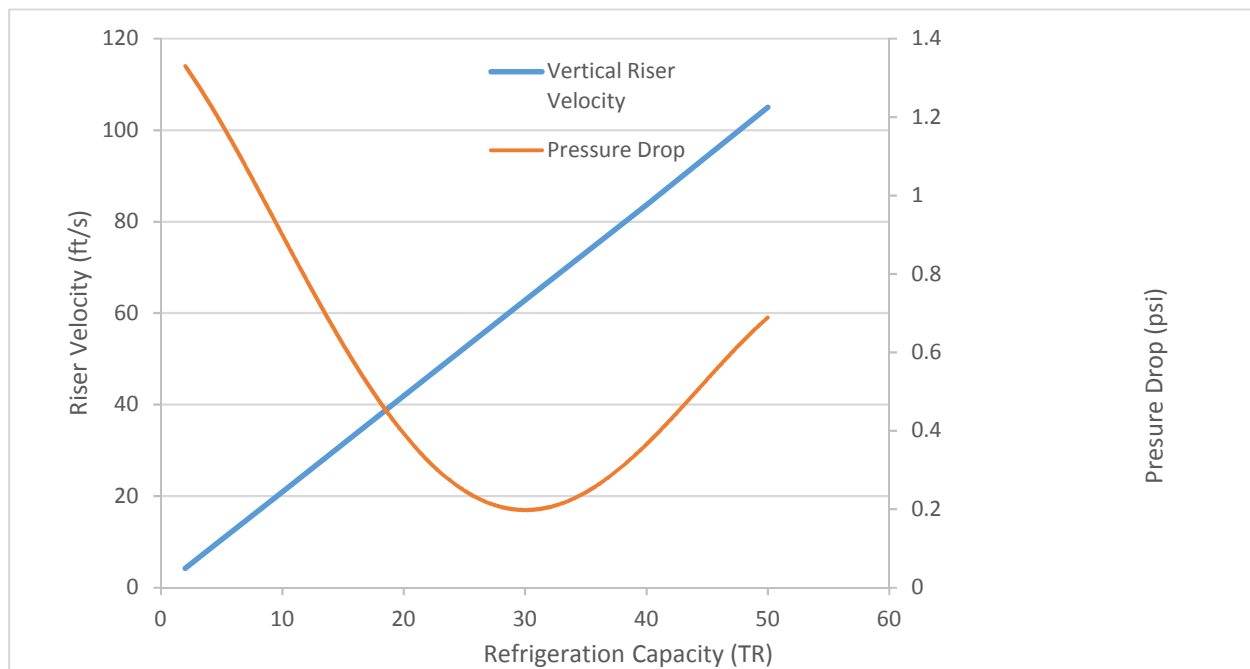
In systems that have a widely varying load, it is very difficult to avoid liquid stacking at all times. Figure 4 shows the approximate vapour velocity in the suction riser at different load conditions. At low load conditions, there will not be enough vapour velocity to move the liquid up the riser effectively. Freeze dryer cold traps are uniquely at risk of low load conditions because they operate in an ambient vacuum which eliminates almost all heat transfer by convection. Effectively, the cold trap is limited to radiation and conduction to absorb energy. The energy input from radiation comes from the surrounding chamber. Heat transfer by conduction occurs between the cold trap and the ice. There is an energy input when water vapour deposits (changes from a gas directly to solid ice) on the surface. Collecting the water vapour is the purpose of the cold trap and constitutes the majority of the heat input since the radiation load on the white surface is likely low in comparison. The amount of water that is collected on the cold trap is proportional to the difference in the vapour pressure between the product and the cold trap. This means that in order for water to collect, there needs to be a temperature difference between the product and the cold trap, and the chamber must be in a low enough vacuum to facilitate the sublimation of ice out of the product.

Figure 4: The approximate velocity and corresponding pressure drop in the 2.5" suction riser for several refrigeration capacities. Data was used from the VPS 2010 Software was used to create this chart (IIAR, 2010).

Figure 4 also shows that a high pressure drop would have occurred in periods of high load. Sizing vertical wet suction risers is a challenge and there is always a balance between pressure drop at design conditions and liquid stacking effects at low loads.

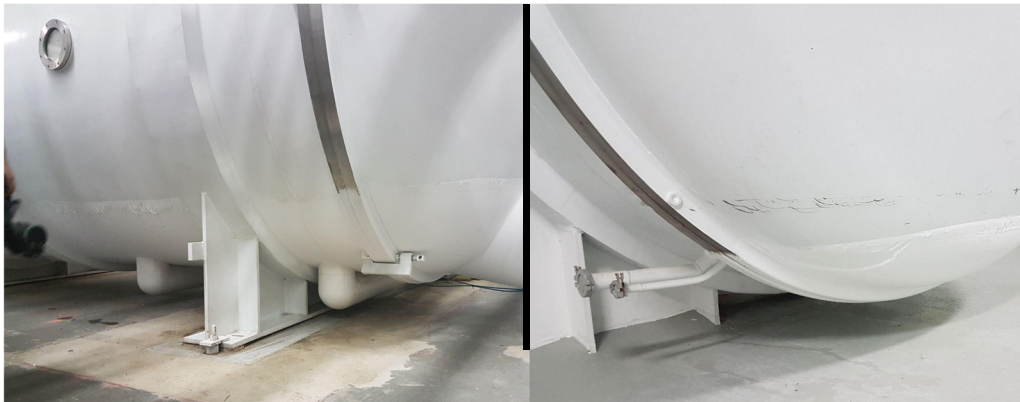
The freeze dryer contained the ammonia and exhausted it through the vacuum pump exhaust. Evidence of the liquid level can be seen in Figure 5 by the frost line on both sides of the freeze dryer. There is a barrier/dam in the freeze dryer vessel that separates the cold trap area so that it can be sprayed with water in a defrost. The liquid level was scaled using the pictures and matches the height of the dam in the cold trap area. The liquid level on the product side of the freeze dryer appears to be significantly lower, which is consistent with flow over the barrier.

Figure 5: Ammonia frost line in the freeze dryer after the release.

The approximate volume of the liquid shown in Figure 5 is 650 USG (2460 L); approximately 3860 lb (2412 kg) of ammonia would be required to achieve this liquid level. Since the cold trap would have contained 465 lb (211 kg) when it was isolated and the liquid piping would have only added additional 20 lb (9.1 kg) of refrigerant to the release, it seems likely that a significant portion of the solution in the freeze dryer was water that melted off of the evaporators following the release. Depending on the exact timing of the failure during the freeze dryer cycle, it is possible that approximately 35% of the solution was ammonia which would result in an ammonia release of approximately 1500 lb (680 kg). A system upset or other unreported condition in which liquid was able to leak into the evaporator are a possibility, but no evidence was found to indicate that these events occurred. Without additional information, it is not possible to refine these calculations.

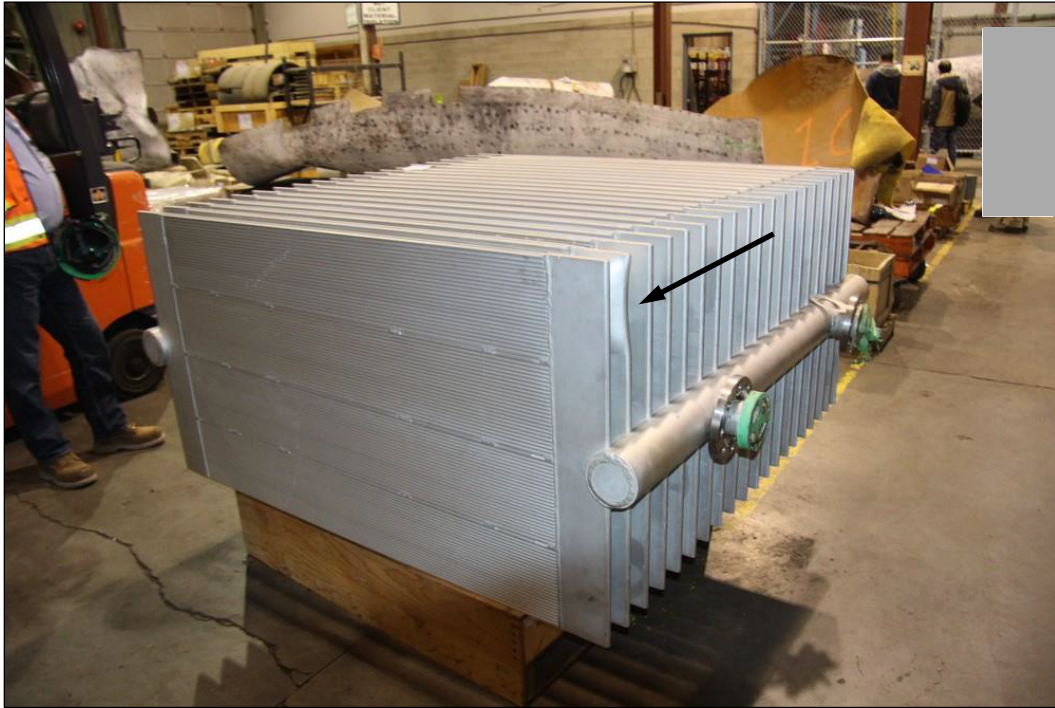
Overall views of the cold trap as received at the Richmond facility are shown in Figures 1 and 2. A single bulged and fractured header plate was found at the location marked with an arrow in Figure 1. A closer view of the bulged end plate (2nd plate over from end) is shown in Figure 3. The bulge appears uniformly distributed on both sides of the plate axis. The plate is torn on both sides of the end plate at the toe of the welds and transitioning to the middle of the welds as shown in Figures 4 and 5.

Figure 1 Overall view of cold trap as received at the Acuren facility. Bulged header is shown at the arrow.

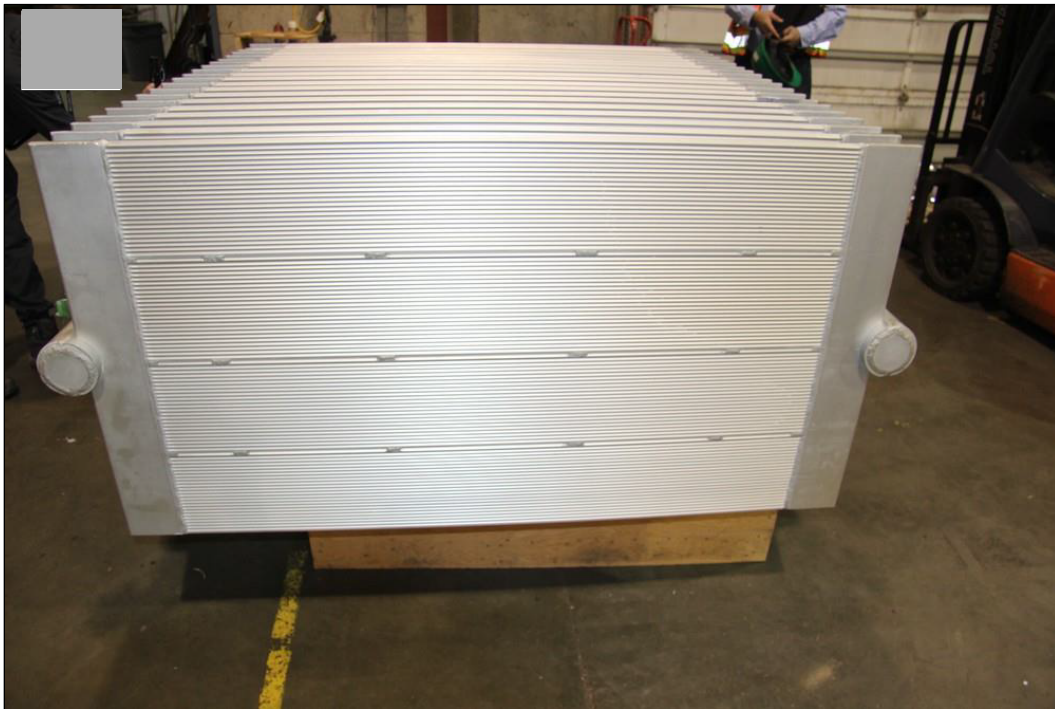
Each plate was checked with a square and level to determine if any bulging occurred in other cold trap plates. No plate distortion was observed at any location away from the bulged end plate on the second row.

Figure 2 Side plates showing no evidence of deformation.

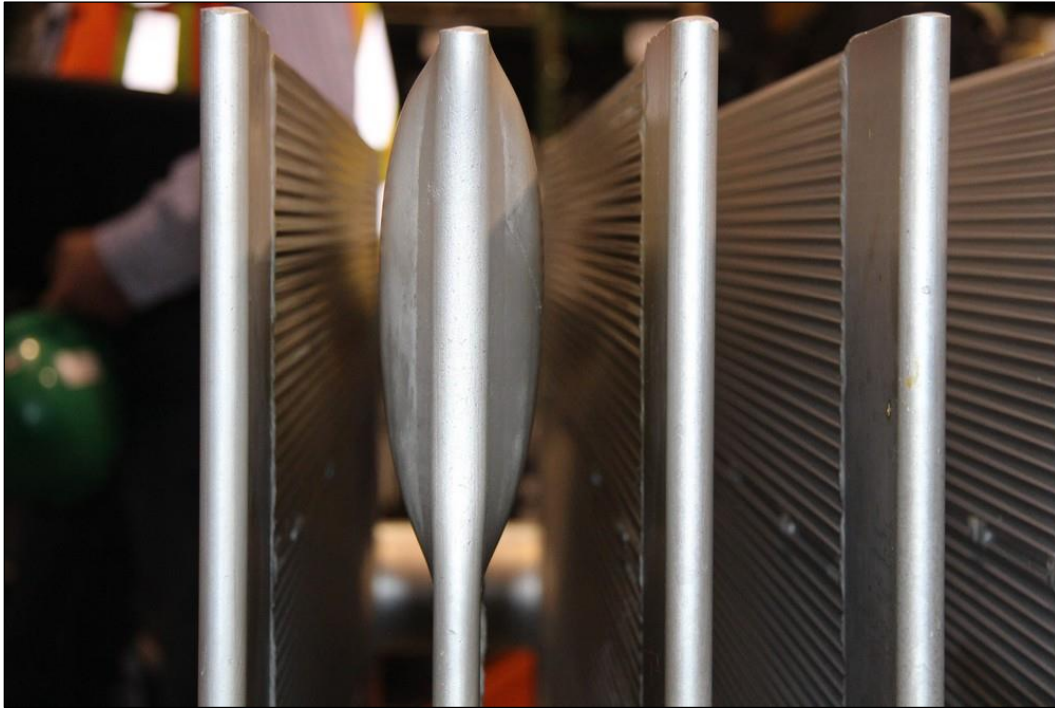
Figure 3 End view of bulge on top of 2nd plate over from side of unit.

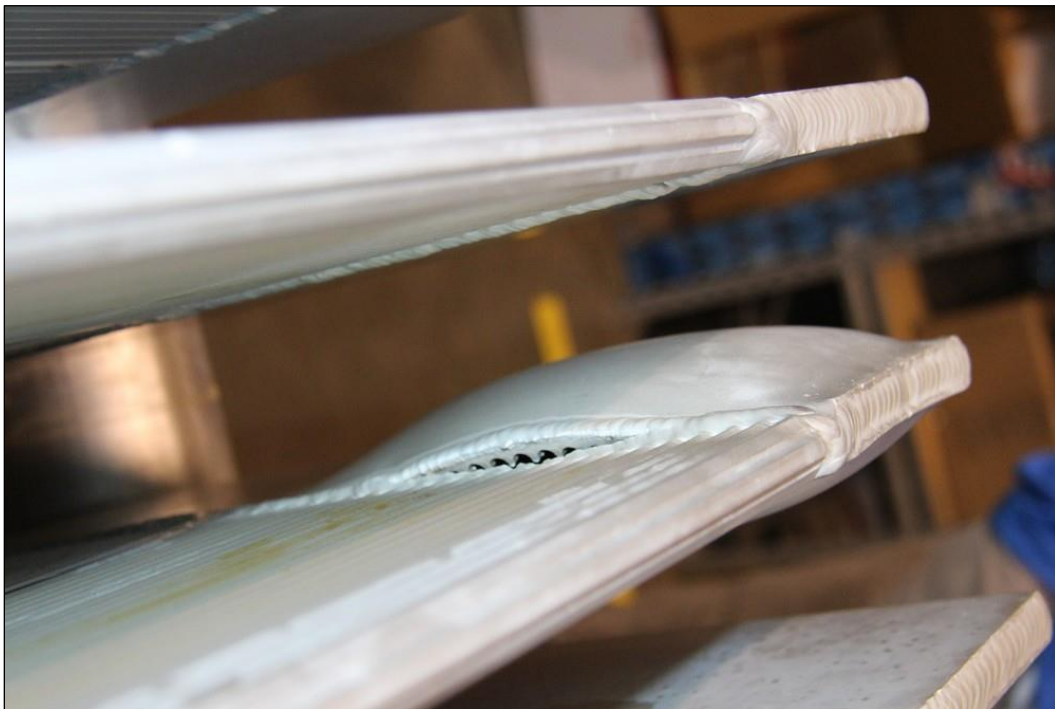
Figure 4 Weld tearing at bottom of bulge. Identical tearing was found on both sides of bulge (see Figure 5).

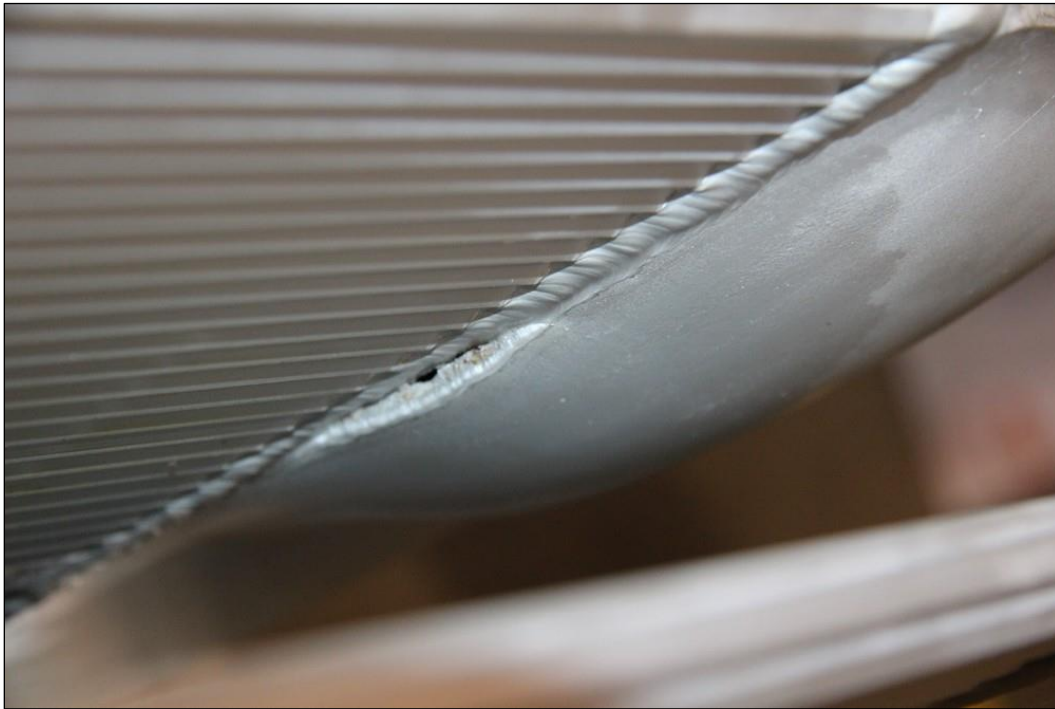
Figure 5 Weld tearing at bottom of bulge opposite (see Figure 4).

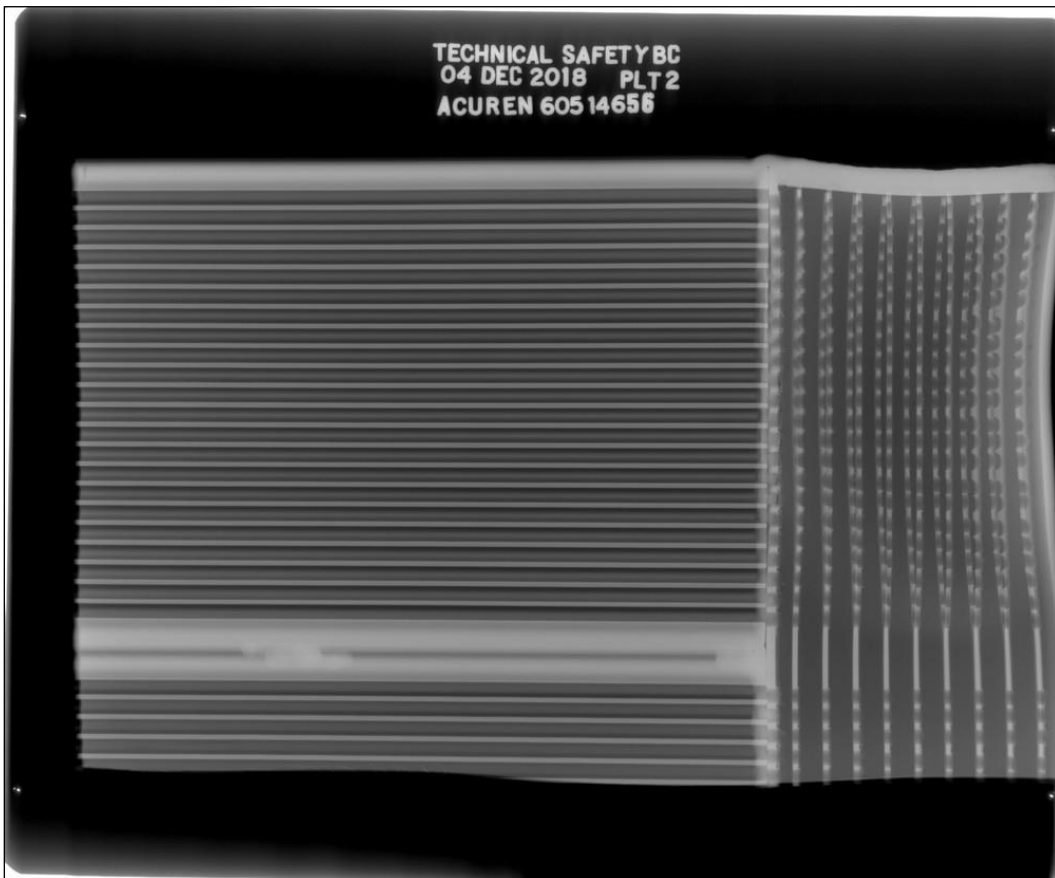
Figure 8 X-ray of bulged plate showing deformation and varying thickness between drilled holes. No obstructions are present.

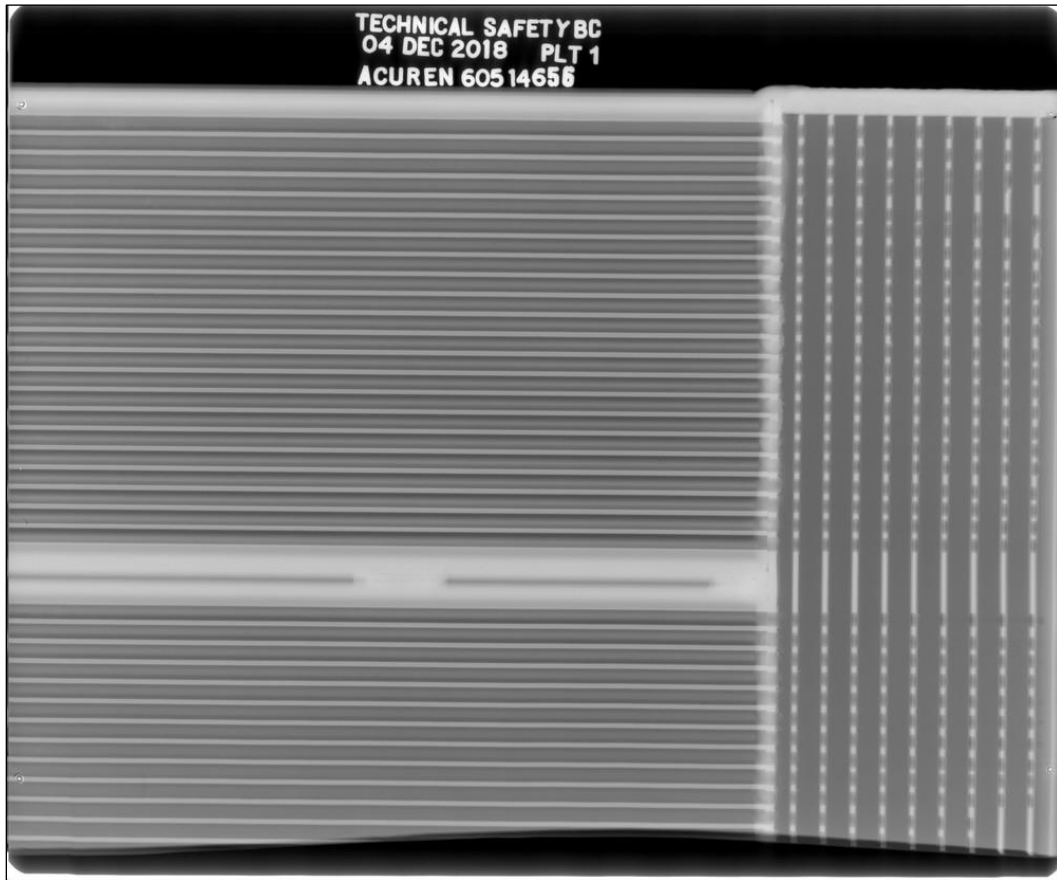
Figure 9 X-ray of exemplar plate showing variability between drilled holes. No obstructions are present.

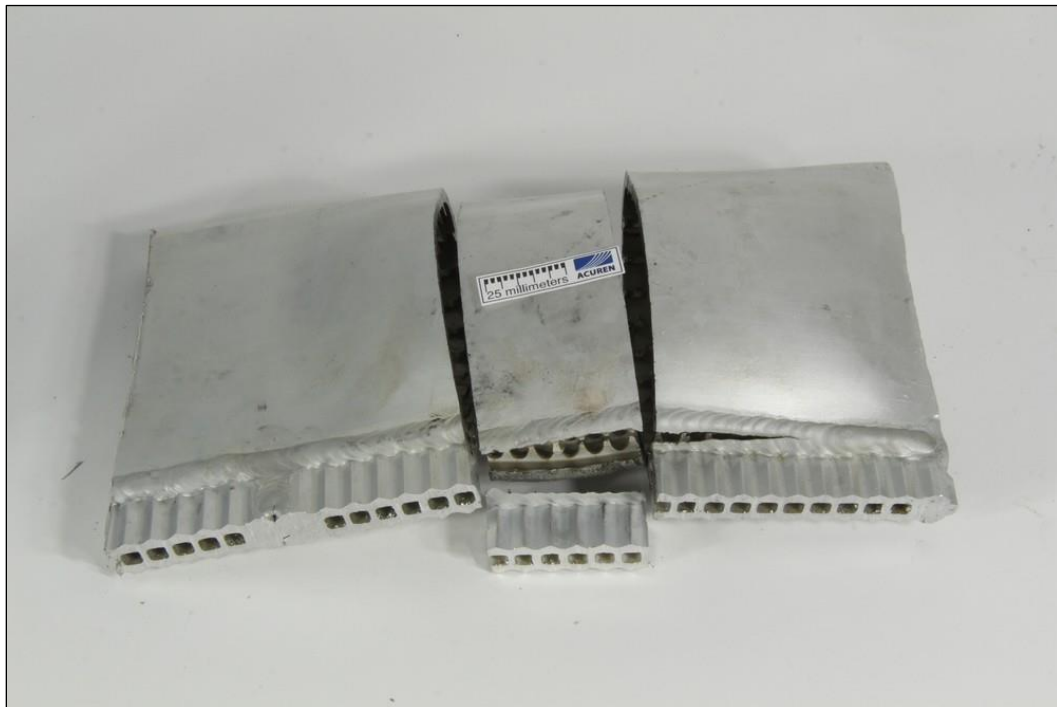
The bulged area was sectioned into 3 pieces as shown in Figure 10. The internal surface consisted of drilled holes, extruded channels, and fractured inter-hole material (Figure 11). Where the holes were drilled off-centre, the distance between adjacent holes varied. This had the effect of weakening the header plate in the

Figure 10 Bulged plate cut to reveal internal construction.

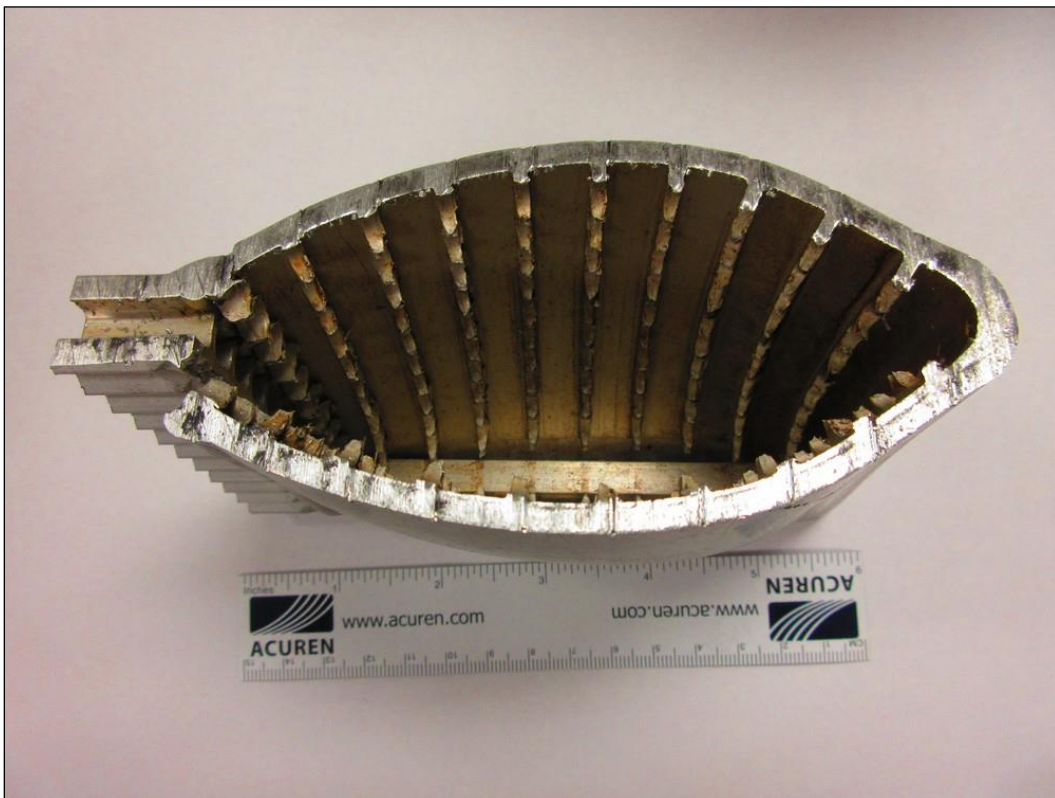
Figure 11 Bulged plate integral surface. The legs between each hole have fractured.

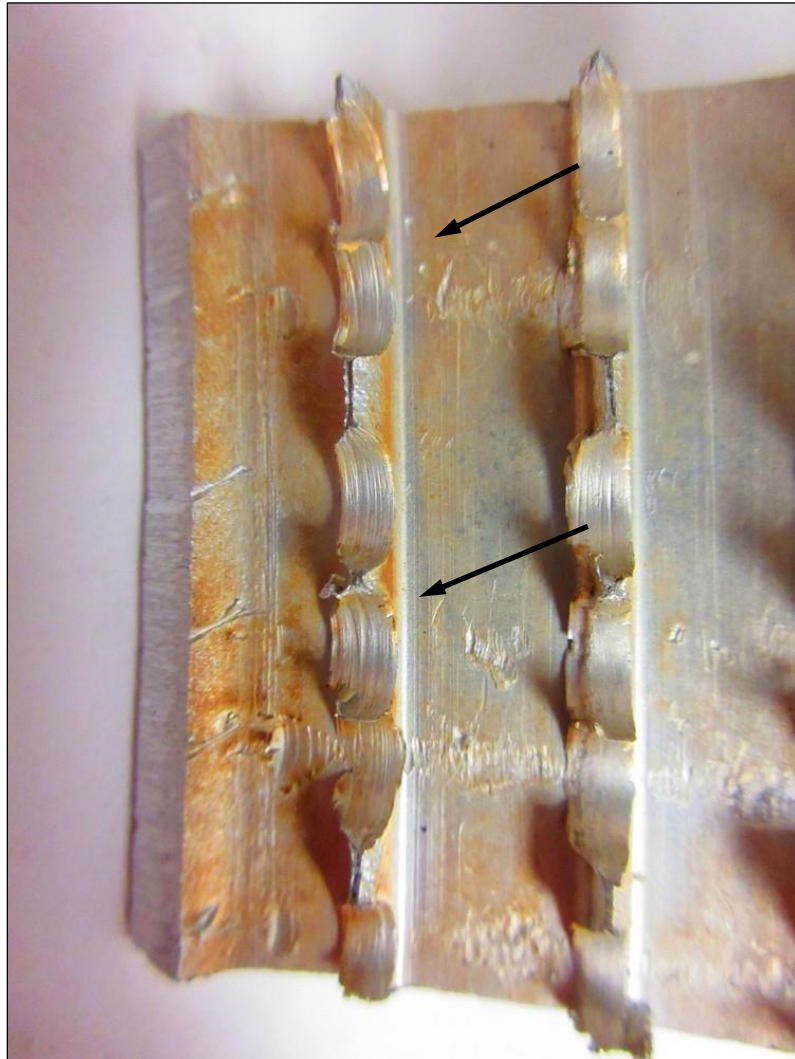
“bulging” direction. The inter-hole fractures all appeared as ductile tensile failures (Figure 12).

Figure 12 Close up view of internal leg fractures. Each fracture appears ductile.

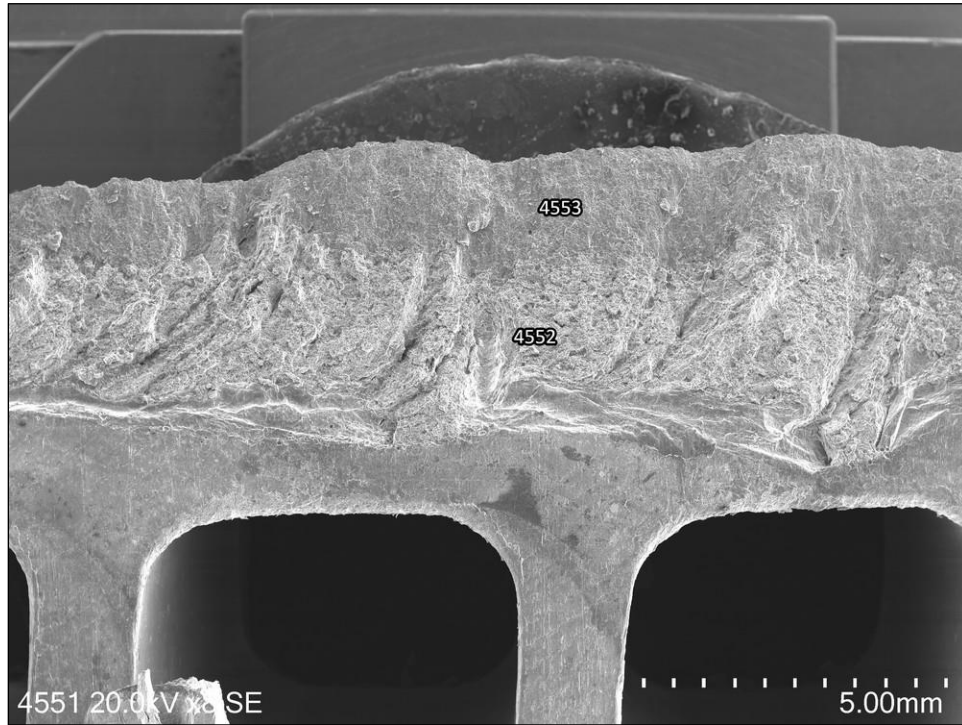
Samples of the header – extruded plate weld fractures were examined in the SEM. A typical fractured joint near the center of the bulge is shown in Figure 13. The fracture surface shows two distinct zones with different textures. The features from the zone nearest the fluid passage holes is shown at high magnification in Figure 14. This zone contains nearly vertical ductile dimples which indicate a straight tensile overload. The zone toward the outer edge of the weld transitions to a mostly

Figure 13 Low magnification SEM view of fractured plate to header weld.

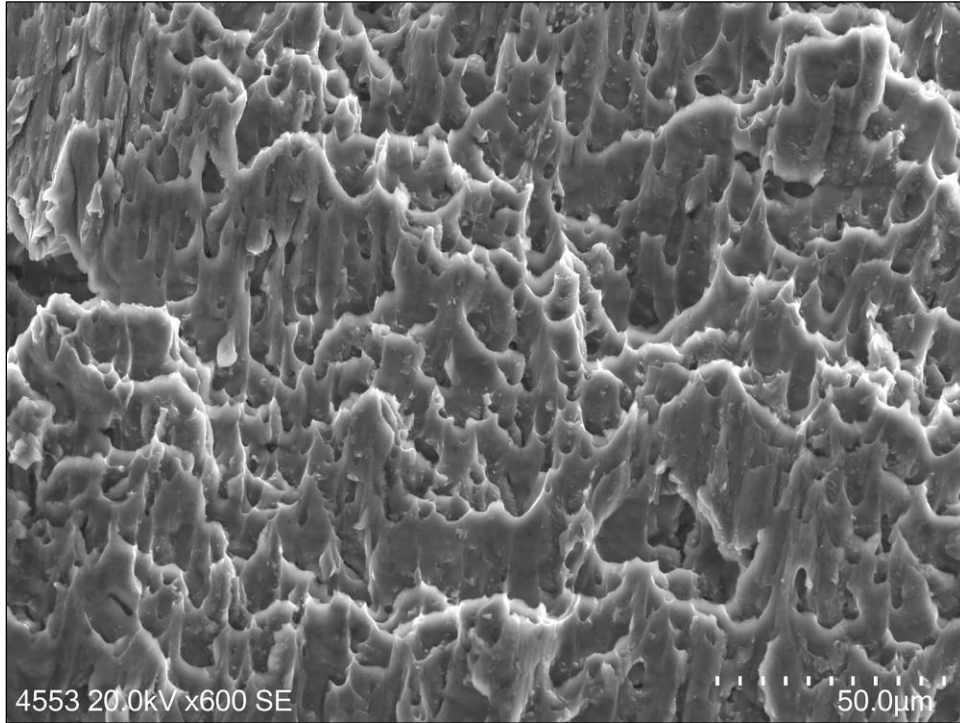
ductile shear condition, with dimples truncated to form horseshoe shapes (Figure 15). The tears on both sides of the bulge contained identical features.

Figure 15 High magnification SEM view of features nearest the header.

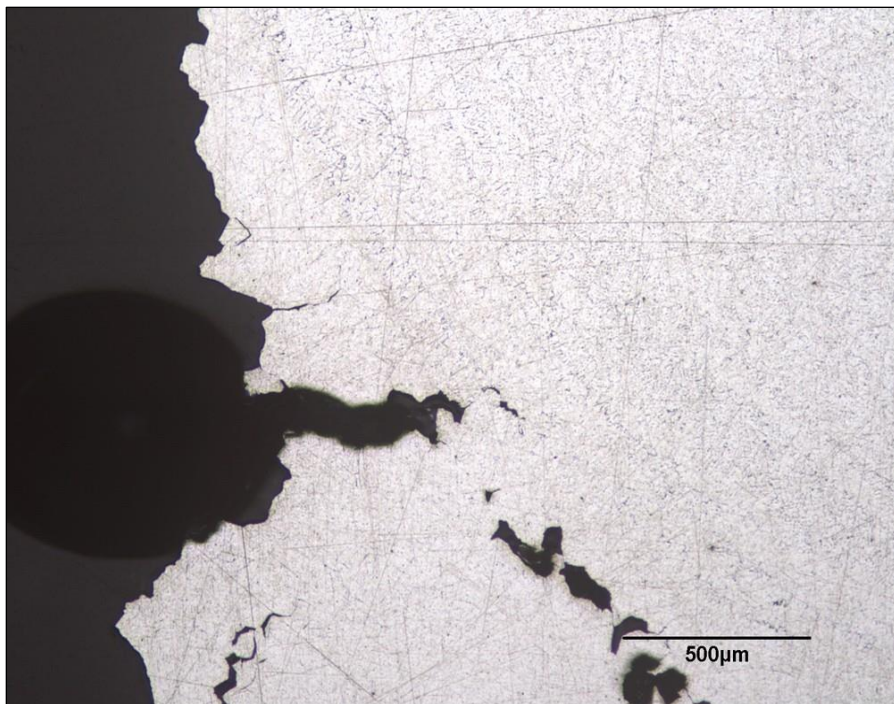
Figure 16 Metallographic view of fracture cross section. Note secondary cracking and porosity in weld metal. (unetched; max 50x.)

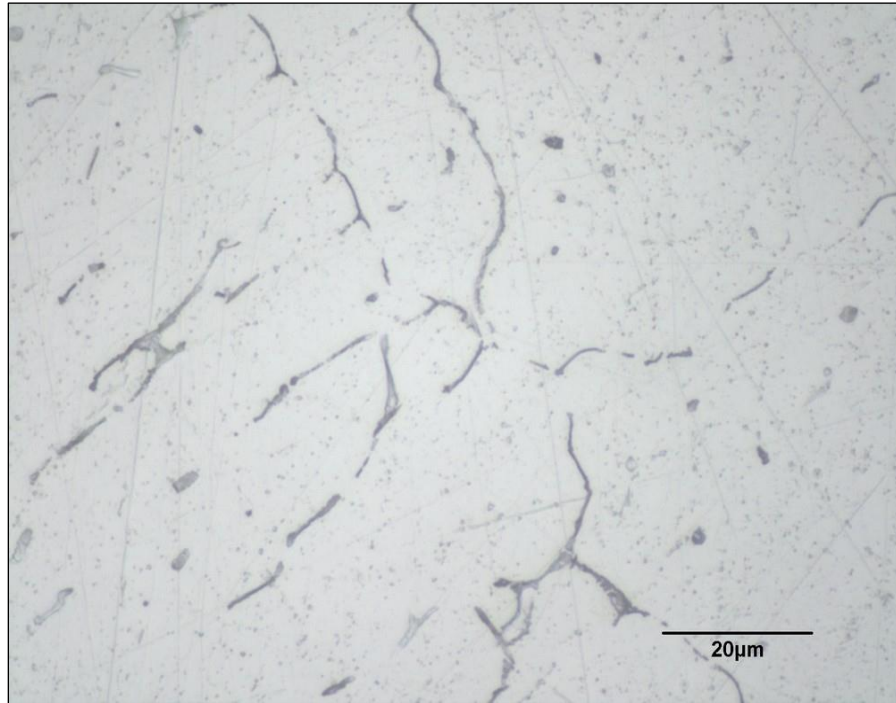
Figure 17 Metallographic view of typical dendritic 2nd phases in weld metal. (unetched; mag 1000x)

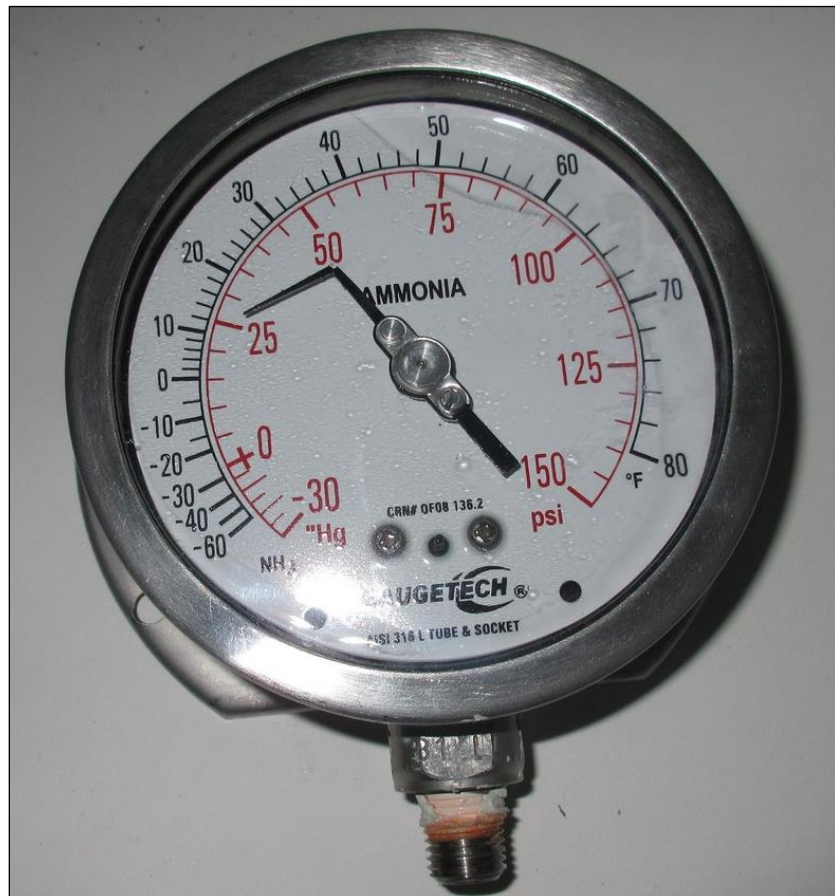
Figure 18 Overall view of damaged pressure gauge attached to cold trap.
