Incident Summary #II-762099-2018 (#9286) (FINAL)

SUPPORTING INFORMATION	Incident Date	October 24, 2018	
	Location	Langley	
	Regulated industry sector	Refrigeration – Boilers and Pressure Vessels	
	Impact	Qty injuries	0
		Injury description	N/A
		Injury rating	N/A
	Damage	Damage description	Ruptured evaporator (also referred to as heat exchanger or cold trap) released estimated 485 to 1,500 lbs of ammonia from refrigeration system and resulted in an extensive area evacuation for two days.
		Damage rating	Major
	Incident rating	Major	
	Incident overview	<p>After unscheduled maintenance to drain oil from the pumps, the refrigeration system was noted to be slow to return to performance and oil contamination of some system evaporators was suspected.</p> <p>The responding refrigeration mechanic stated he attempted to improve system performance by closing valves to generate pressure within an evaporator to move or dislodge potentially trapped oil. The pressure rose very rapidly once the evaporator was isolated between closed valves, breaking a pressure gauge needle (photo 3) and rupturing the evaporator (photos 1 and 2).</p> <p>An estimated 485 to 1,500 lbs of ammonia was released from t

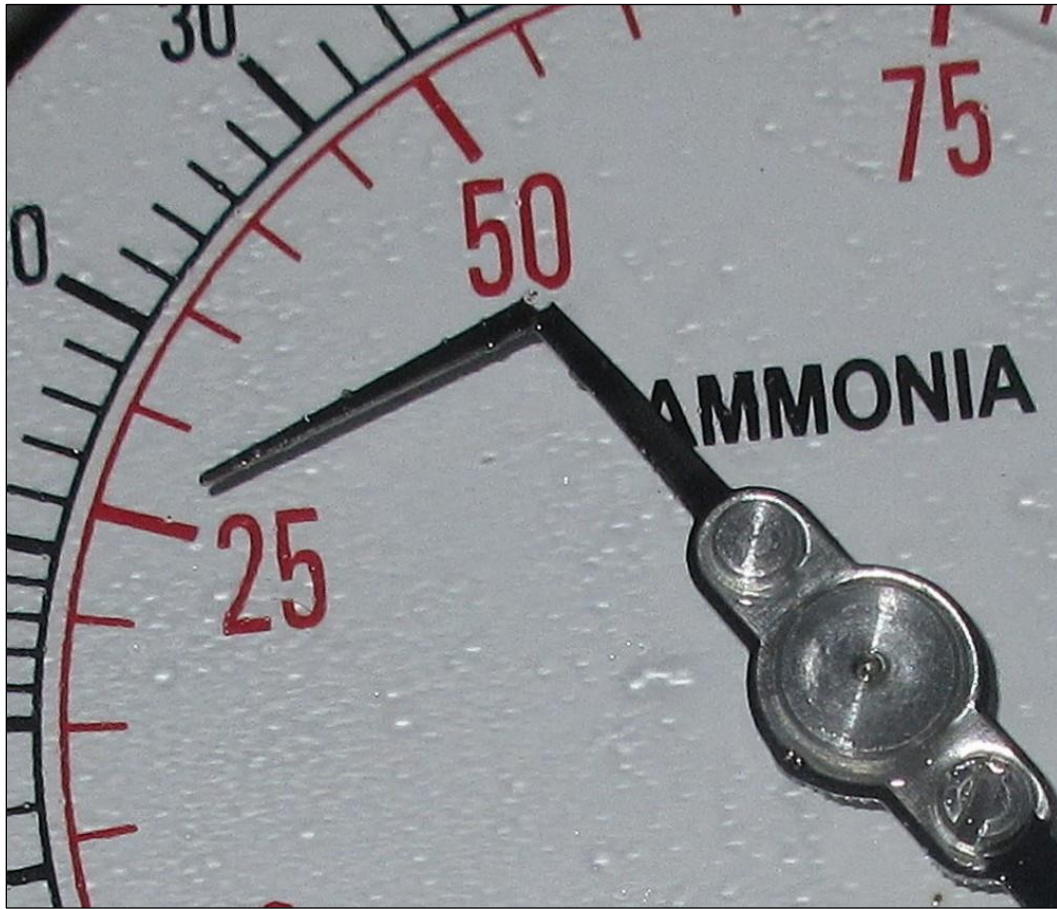
Figure 19 Closer view of fractured needle.

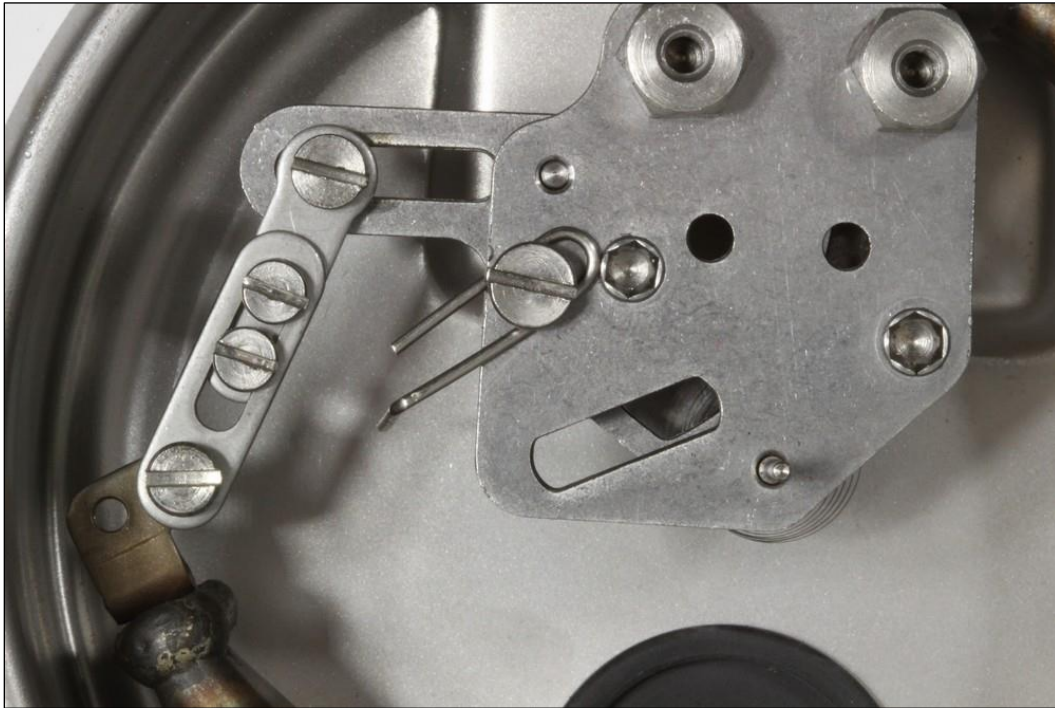
Figure 21 Closer view of linkages and adjustment screws within damaged gauge.
