Incident Summary #II-762099-2018 (#9286) (FINAL)

SUPPORTING INFORMATION	Incident Date	October 24, 2018	
	Location	Langley	
	Regulated industry sector	Refrigeration – Boilers and Pressure Vessels	
	Impact	Qty injuries	0
		Injury description	N/A
		Injury rating	N/A
	Damage	Damage description	Ruptured evaporator (also referred to as heat exchanger or cold trap) released estimated 485 to 1,500 lbs of ammonia from refrigeration system and resulted in an extensive area evacuation for two days.
		Damage rating	Major
	Incident rating	Major	
	Incident overview	<p>After unscheduled maintenance to drain oil from the pumps, the refrigeration system was noted to be slow to return to performance and oil contamination of some system evaporators was suspected.</p> <p>The responding refrigeration mechanic stated he attempted to improve system performance by closing valves to generate pressure within an evaporator to move or dislodge potentially trapped oil. The pressure rose very rapidly once the evaporator was isolated between closed valves, breaking a pressure gauge needle (photo 3) and rupturing the evaporator (photos 1 and 2).</p> <p>An estimated 485 to 1,500 lbs of ammonia was released from t

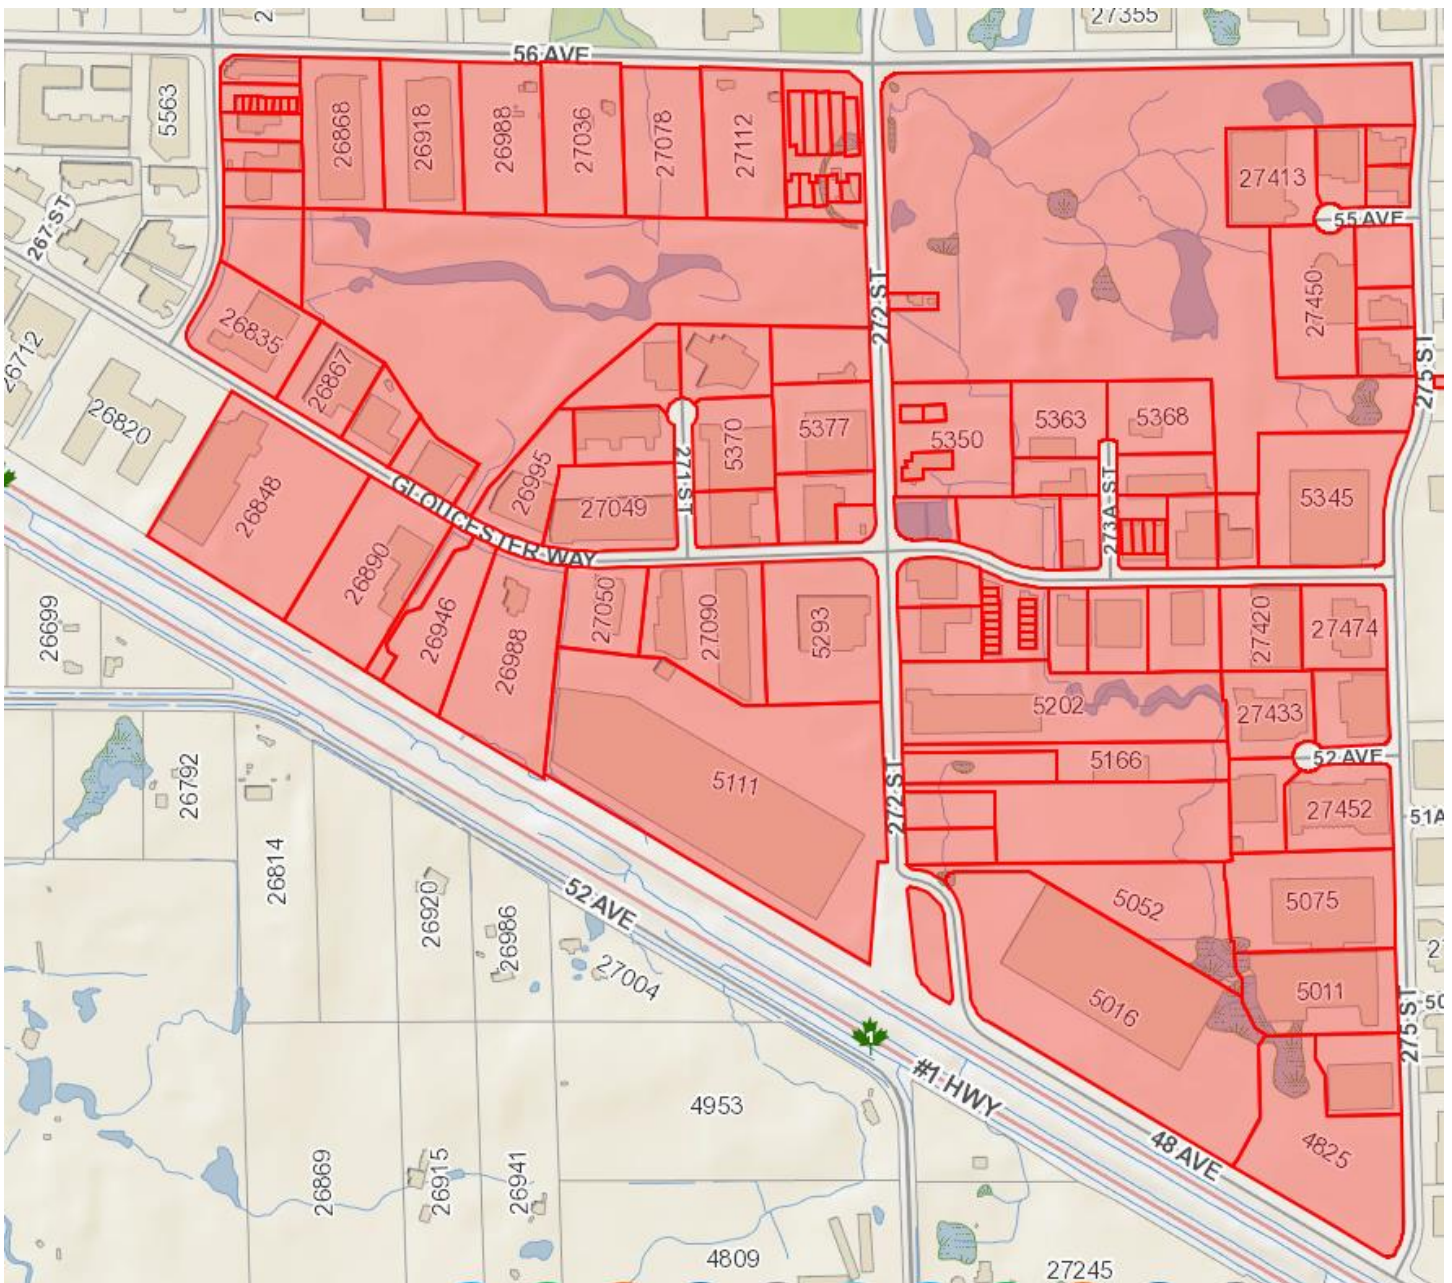
Diagram 1: Evacuation area enforced and [communicated by the Township of Langley](#) while responding to the ammonia release. Affected area is industrial and the evacuation was enforced for approximately 48 hours from October 24th through October 26.

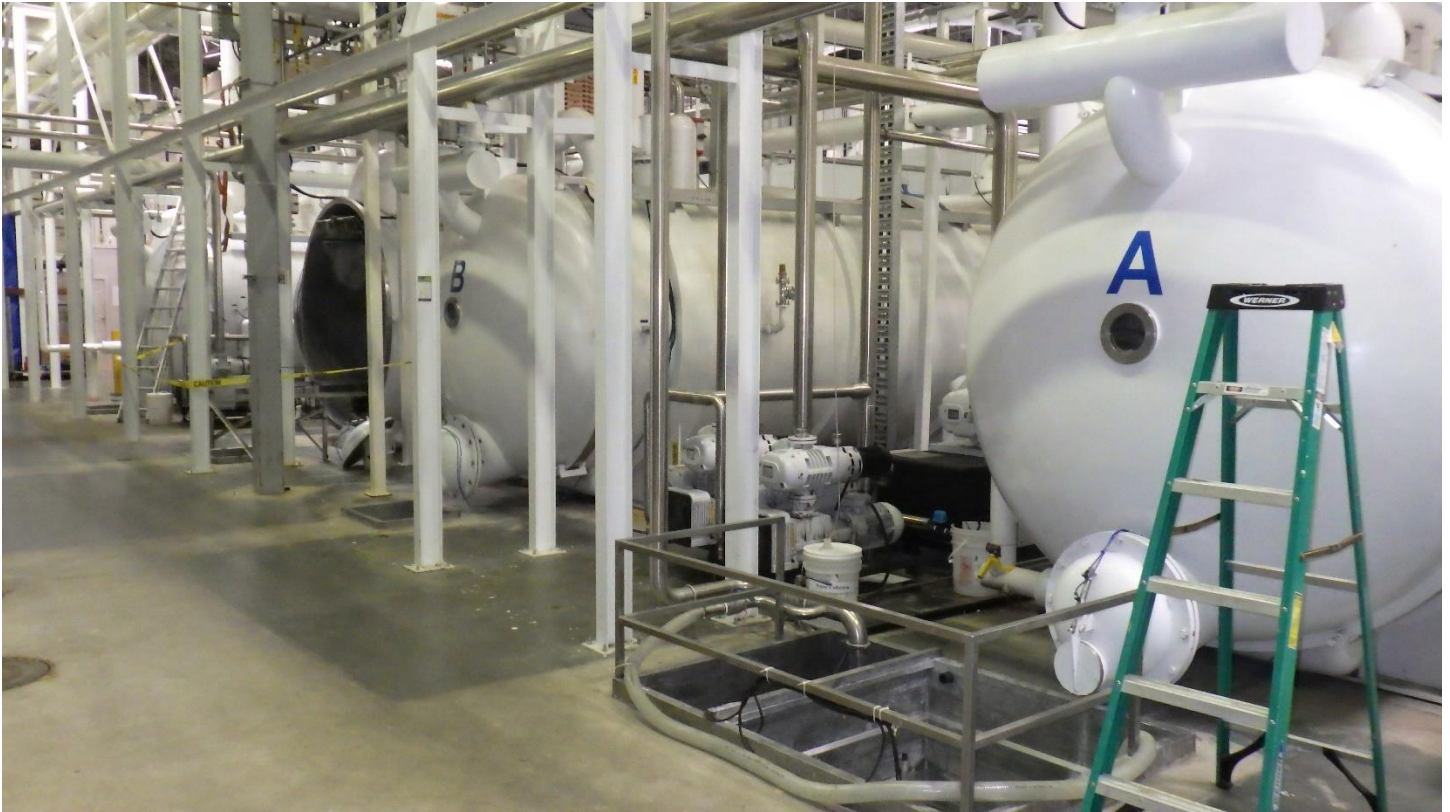
Photo 4: Freeze drying chambers at processing facility. Labels visible on chambers A and B while access door is opened on chamber C.

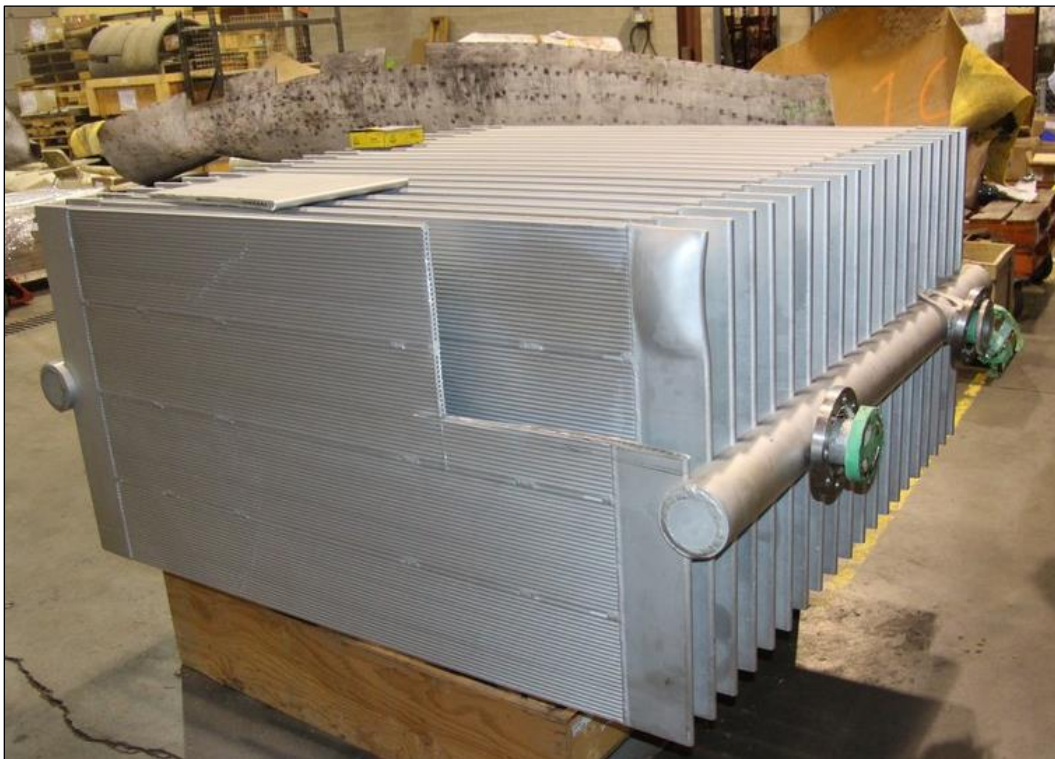
The outer edge header was cut out to expose the bulged header plate on the second row of plates (Figure 6). A rectangular piece approximately 12” x 17” was cut from this location. A rectangular piece approximately 10” x 16” surrounding the bulged plate end was cut from the second row as shown in Figure 7. These two plates were sent for X-Ray inspection before any further cutting was done. The x-rays (Figures 8 and 9) did not reveal any blockages. However, the drilled holes in the header appeared off-centre in both x-rayed plate pieces, with the distance between each hole different depending on the depth of the measurement.

Figure 6 Cut out on edge plate to reveal bulged plate on 2nd row.

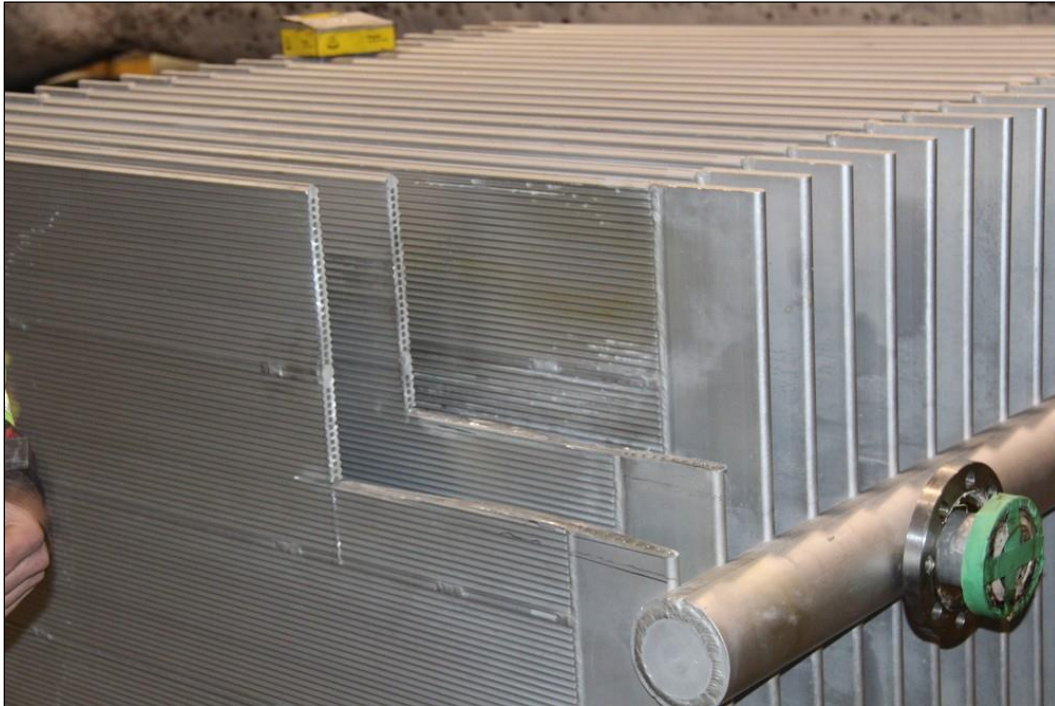
Figure 7 Bulged plate removed from 2nd row.

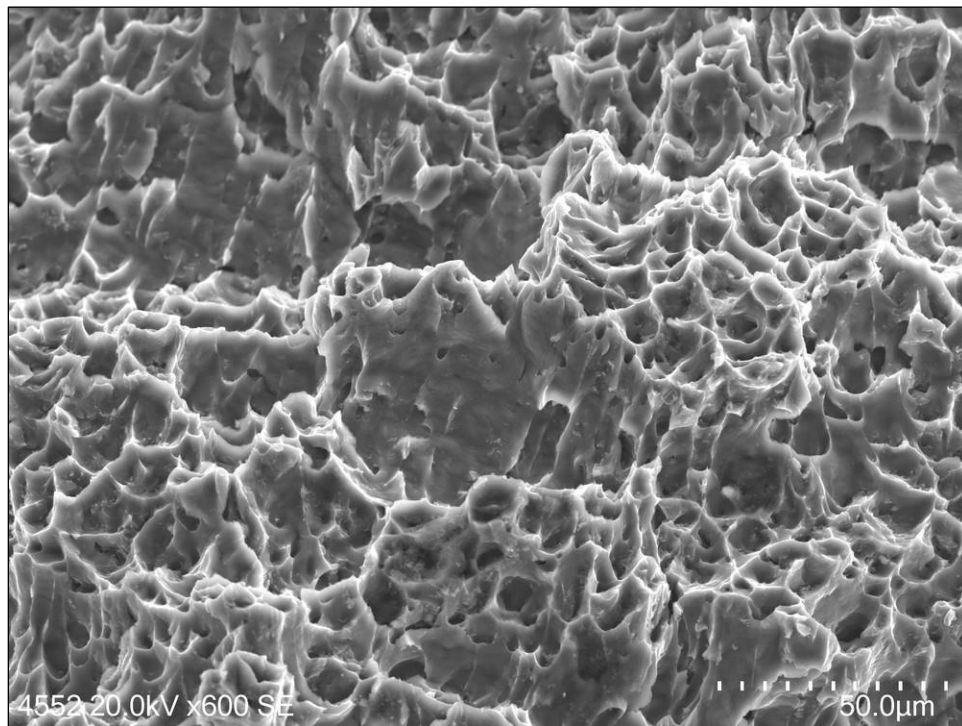
Samples of the header – extruded plate weld fractures were examined in the SEM. A typical fractured joint near the center of the bulge is shown in Figure 13. The fracture surface shows two distinct zones with different textures. The features from the zone nearest the fluid passage holes is shown at high magnification in Figure 14. This zone contains nearly vertical ductile dimples which indicate a straight tensile overload. The zone toward the outer edge of the weld transitions to a mostly

Figure 14 High magnification SEM view of features nearest the plate.

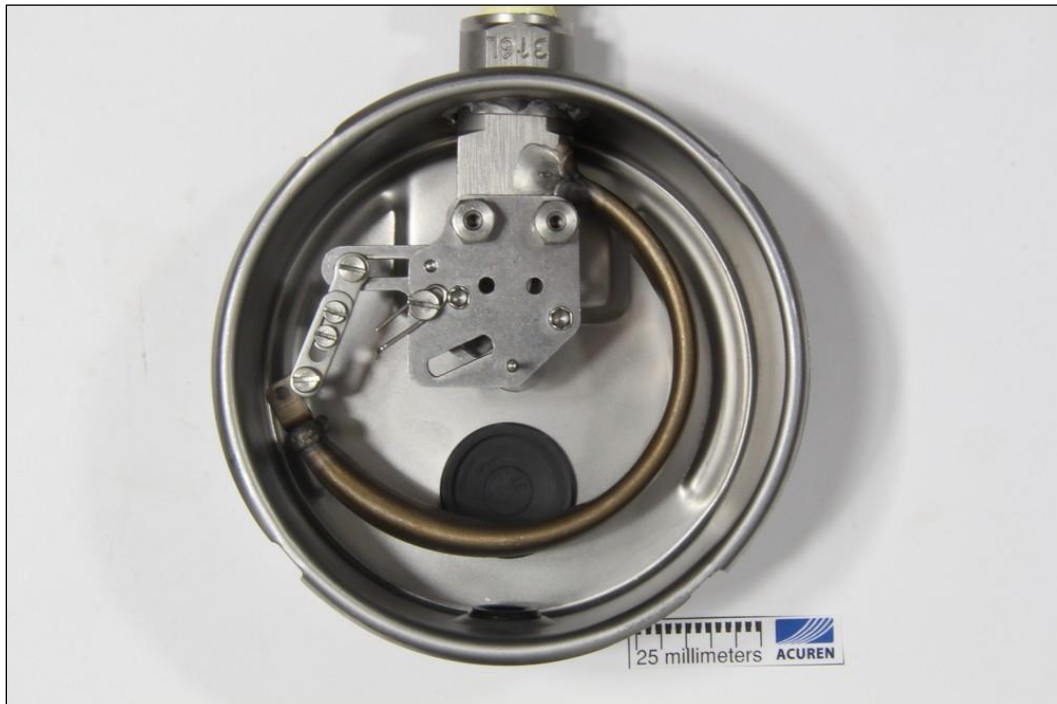
The internal components of the damaged gauge are shown in Figures 20 and 21. All of the components, including the pressure tube, appear undeformed and intact. The screw adjustments on the operating levers may have moved slightly to destroy the calibration of the gauge.

Figure 20 Overall view of internal components.
